Source: *APT Bulletin: The Journal of Preservation Technology*, 2020, Vol. 51, No. 4, Special Issue: Mitigating Vibration Damage (2020), pp. 6-12

# Protecting Stained-Glass Windows from Vibrations Caused by Construction Operations

Dean Koga  
Erica Morasset  
Raymond Pepi  
David Woodham

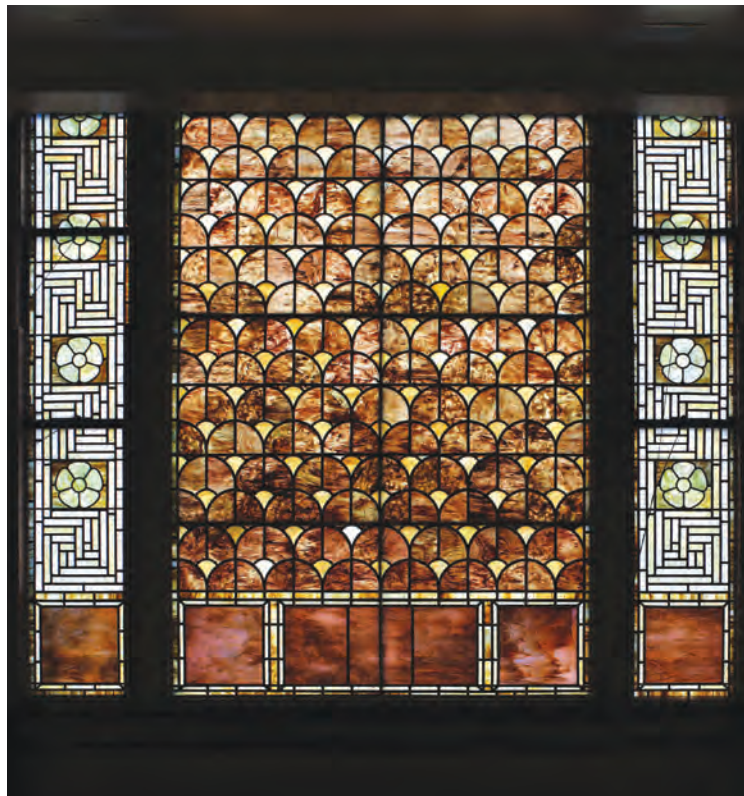
Fig. 3. Window detail, north elevation. Note the cords on the right to open and close the operable panels. Photograph by Whitney Cox, 2015.

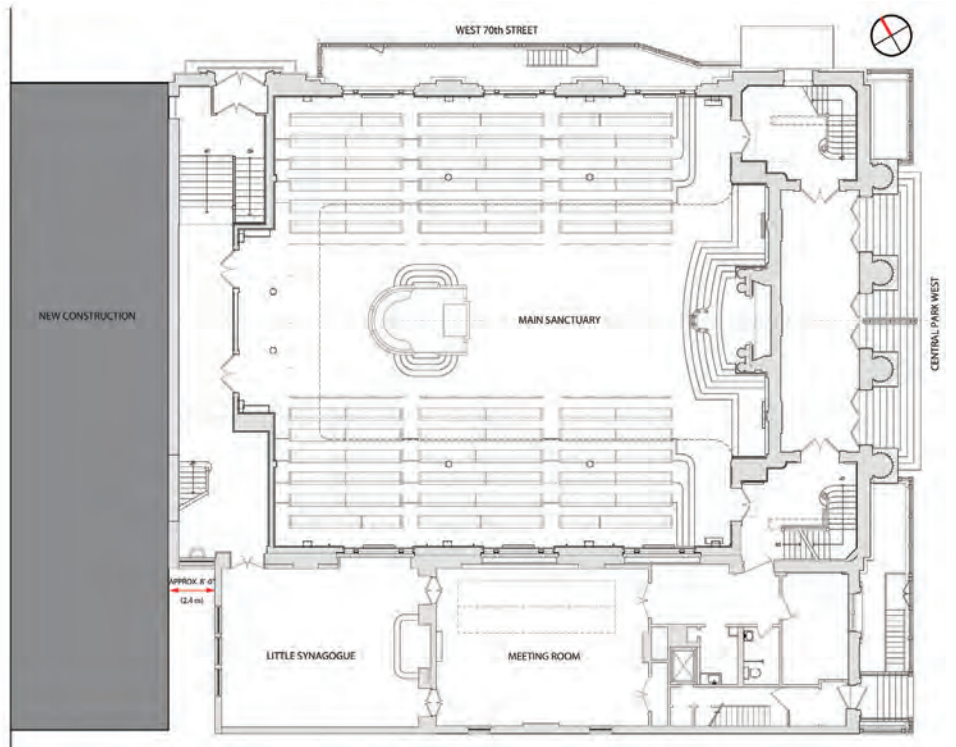
Fig. 4. First-floor plan, 2014. The new construction, which replaced the community house, is approximately 8 feet (2.4 m) distant from the west windows of the Little Synagogue. Drawing by PBDW Architects, 2014.

Work on the first three items was carried out by Mary Clerkin Higgins, who had undertaken the previous restoration work. The contractor for the project installed exterior plywood protection outside of the Little Synagogue, which was directly adjacent to the demolition (Fig. 4).

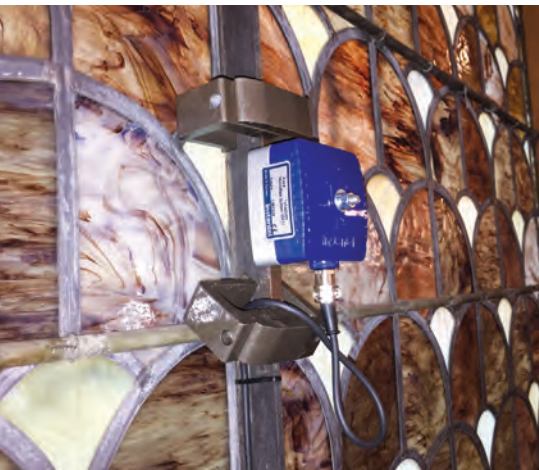
Fig. 6. Geophone mounted on a vertical stabilizing bar with custom clamps. Photograph by ANA, 2015.

ANA developed a monitoring installation that incorporates a series of triaxial geophones mounted with custom-fabricated clamps on the vertical stabilization bars at mid-height or on saddle bars where no vertical bars exist (Figs. 6 and 7). The geophones were set up to measure vibration-related velocity. Custom software was developed to calculate displacement from the vibration data. The geophones were of relatively low mass so as to have a minimal effect on the vibrational response of the windows (Fig. 8). They were connected to a data logger that provides continuous monitoring of data, which is transmitted to a dedicated website via a cell-phone modem. Battery backup kept the system running in the event of power failure.

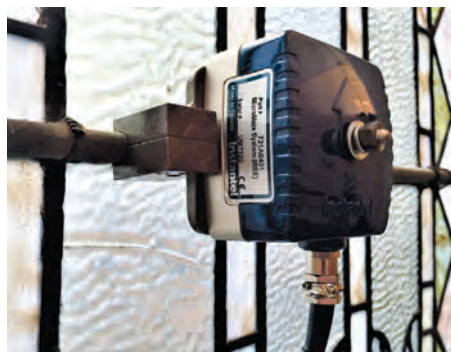
Fig. 7. Geophone mounted on a saddle bar with a custom clamp. Photograph by ANA, 2015.

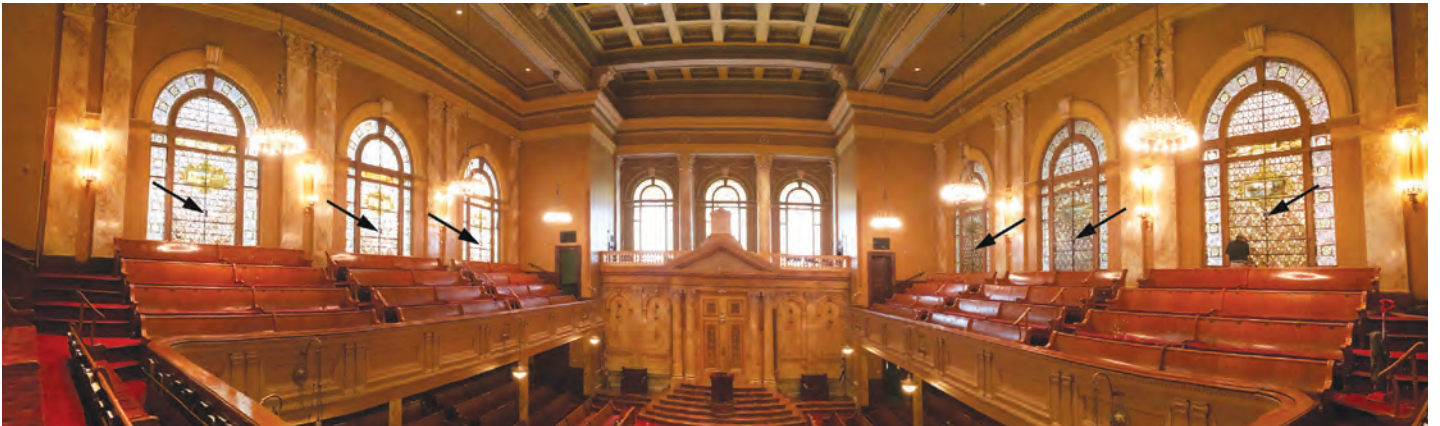
Fig. 8. Sanctuary with east windows removed and geophones in place (black arrows). Photograph by ANA, 2015.

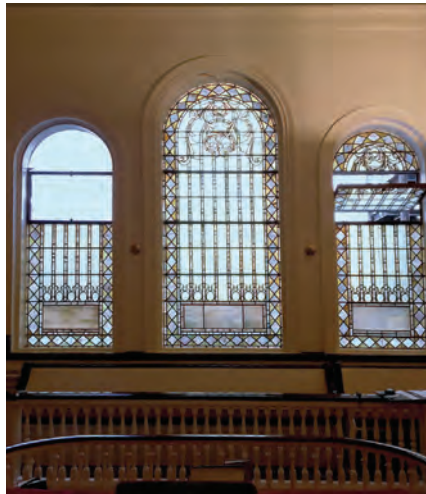
After the initial installation but before demolition commenced, extremely high PPV values (>2 in/sec, 50 mm/sec) were recorded in the Little Synagogue every morning. Observation determined that the pivoting windows were opened before the morning service and then closed with enough force to retract the spring-loaded catch (Fig. 9). Similar high vibrations were recorded on windows in the main sanctuary space on some warm afternoons, attributable to the same factors.

Fig. 9. Open pivot window, Little Synagogue. Damaged panels in the left window were removed for repair in a shop. The construction area is directly behind these windows. Photograph by ANA, 2015.

- remove buckled and significantly damaged panels to an off-site shop for restoration
- repair all glass cracks on-site
- reestablish all ties to support bars
- provide exterior protection to windows adjacent to construction.

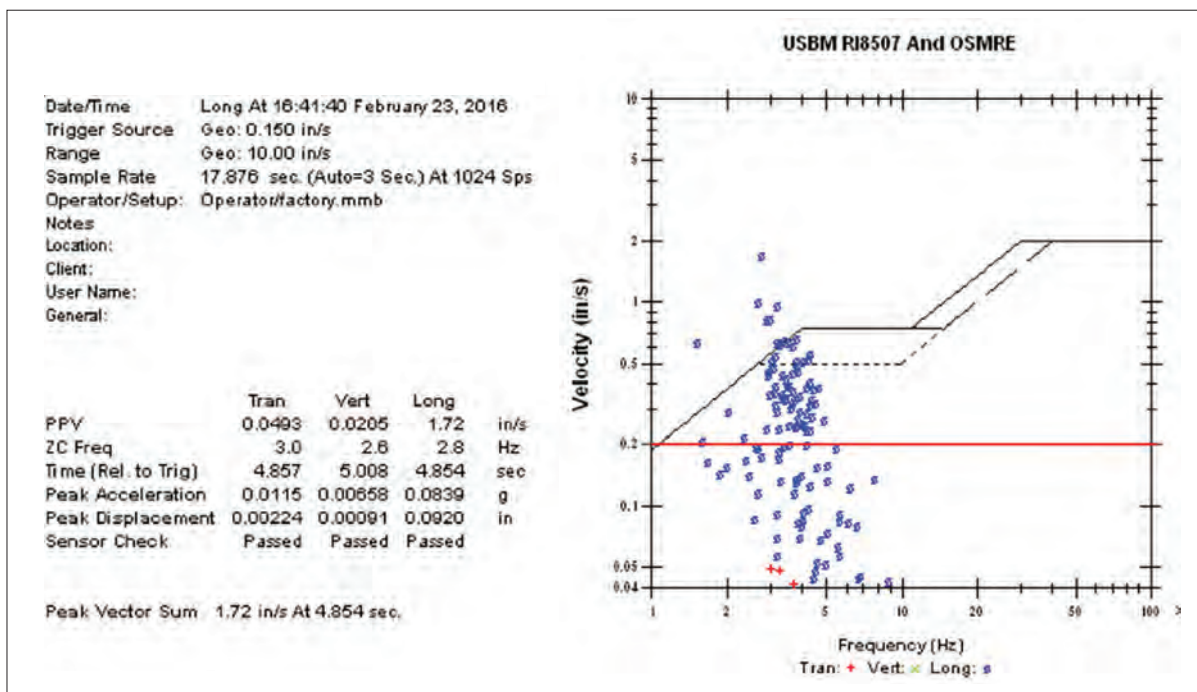
After these adjustments, triggering events were recorded infrequently. Although the PPV thresholds were often exceeded, displacements were usually very low. Afternoon events were usually the result of closing windows forcefully (Fig. 10). Some of the other events occurred late at night, and most of those events corresponded to high winds as recorded by the National Weather Service at its nearby station in Central Park. Some of the large deflections were recorded on the tall windows with protective glazing on the exterior, indicating that the glazing did not protect the stained-glass windows from deflection caused by wind pressure. Vents in such glazing systems are designed to allow air to circulate in order to curtail condensation, but in this instance, they were not adequate to prevent the transmission of instantaneous loads, similar to what occurs in a double-skin drum.

Fig. 10. Excerpt from a data sheet from a recorded event, beginning 0.25 seconds before trigger. The red line in the graph shows the threshold. The event occurred at 4:40 p.m. on a Sunday afternoon, with displacement of 0.092 inches (2.3 mm) above the threshold value of 0.062 inches (1.6 mm). Maximum PPV of 1.72 in/sec (44 mm/sec) exceeded threshold value of 0.2 in/sec (5 mm/sec) by a factor of more than 8. Courtesy of BDI.

The results of installing the monitoring system were positive. The system confirmed that the windows were not damaged by vibrations from construction operations. After the completion of demolition, all windows were surveyed for cracks, comparing the visible cracks to those recorded on the annotated and documentary photographs. Only one new crack was detected, adjacent to an operable panel at which several threshold events were recorded. Because of the damage sustained by the windows as a result of closing the operable panels, a new system of latching is being developed that does not require impact force.
