Cleaning Techniques in Conservation Practice

A Special Issue of the **JOURNAL OF Architectural Conservation**

The Cathedral Church of Saint John the Divine is the third largest church structure in the world. It is located on the upper west side of Manhattan in New York City. A fire in December of 2001 badly damaged the stonework of the unfinished north transept and spread thick black smoke through the entire building. After the fire, a comprehensive investigation was undertaken to identify the unique characteristics of the fire soil and then to use that information to determine the extent to which these materials had deposited on surfaces in the building. A direct correlation was made between the materials of construction that burned during the fire and the particles present in samples of soiling removed from throughout the Cathedral. It was therefore possible to establish that the fire soil had penetrated to all areas of the Cathedral and that all surfaces required cleaning. This paper describes the techniques used to carry out the investigation.

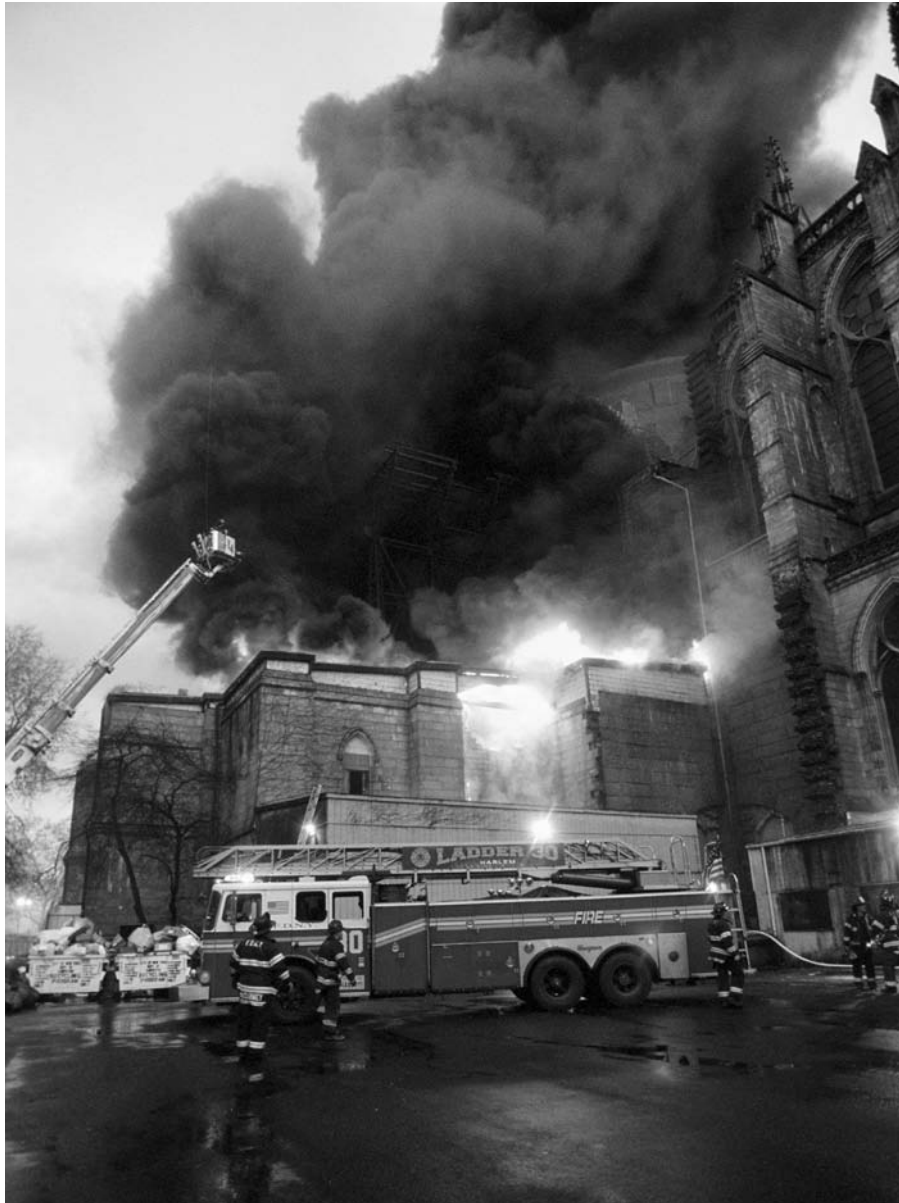
Figure 1 A view of the north transept during the fire, taken from an exterior parking area. (Michael Schwartz/New York Daily News)

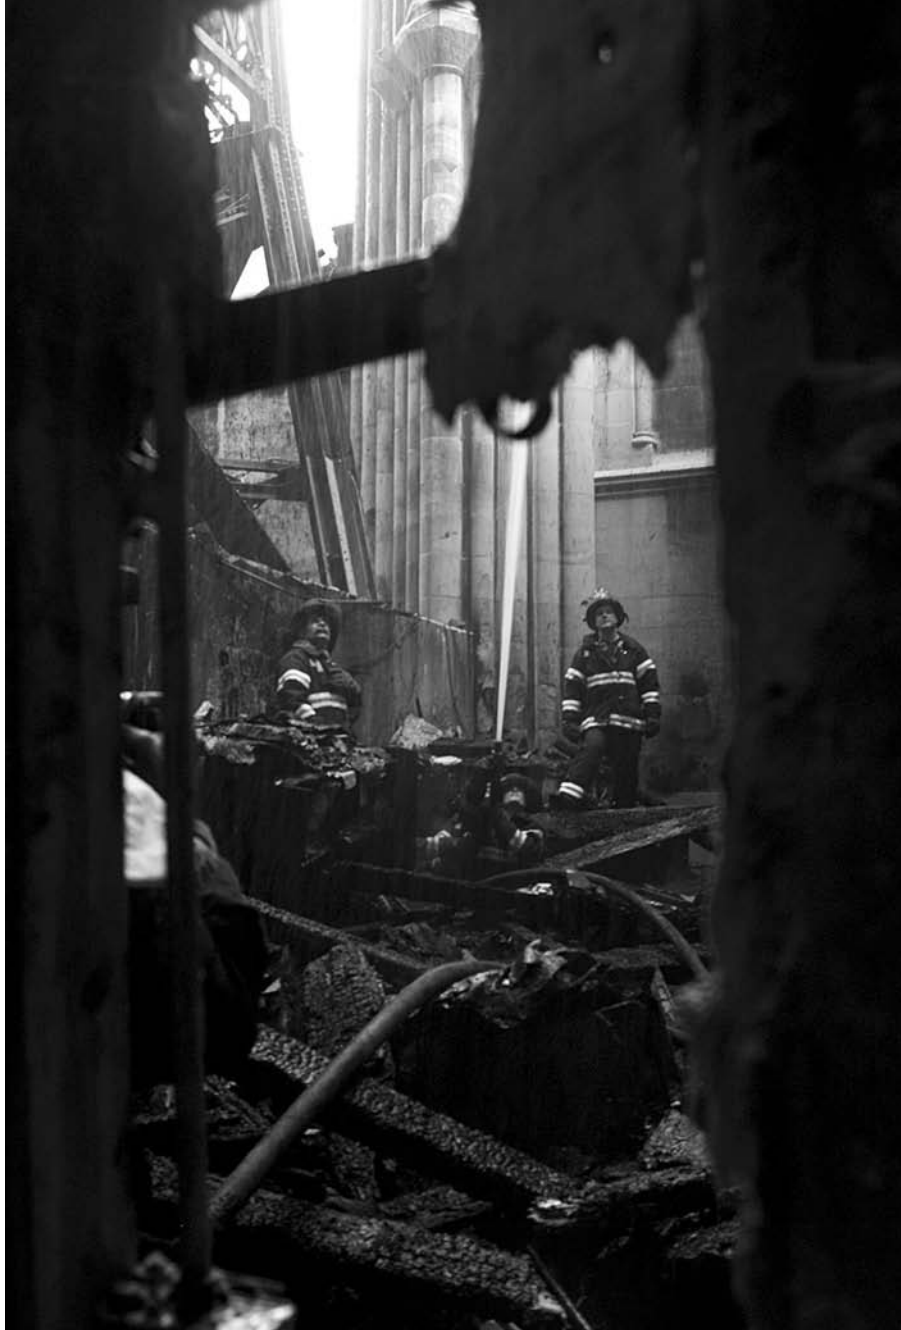
Figure 3 A view of the interior of the north transept after the fire. Charred wood beams and partially melted bituminous materials from the roof structure are in piles on the floor. (Michael Schwartz/New York Daily News)

The primary materials that burned were the roof and the merchandise in the gift shop. Two seventeenth-century tapestries that had been hanging on the north wall of the crossing were badly damaged by the fire. Eyewitnesses report that thick black smoke from the fire travelled throughout the entire interior of the Cathedral. The New York City Fire Department brought the fire under control within several hours (Figure 3).

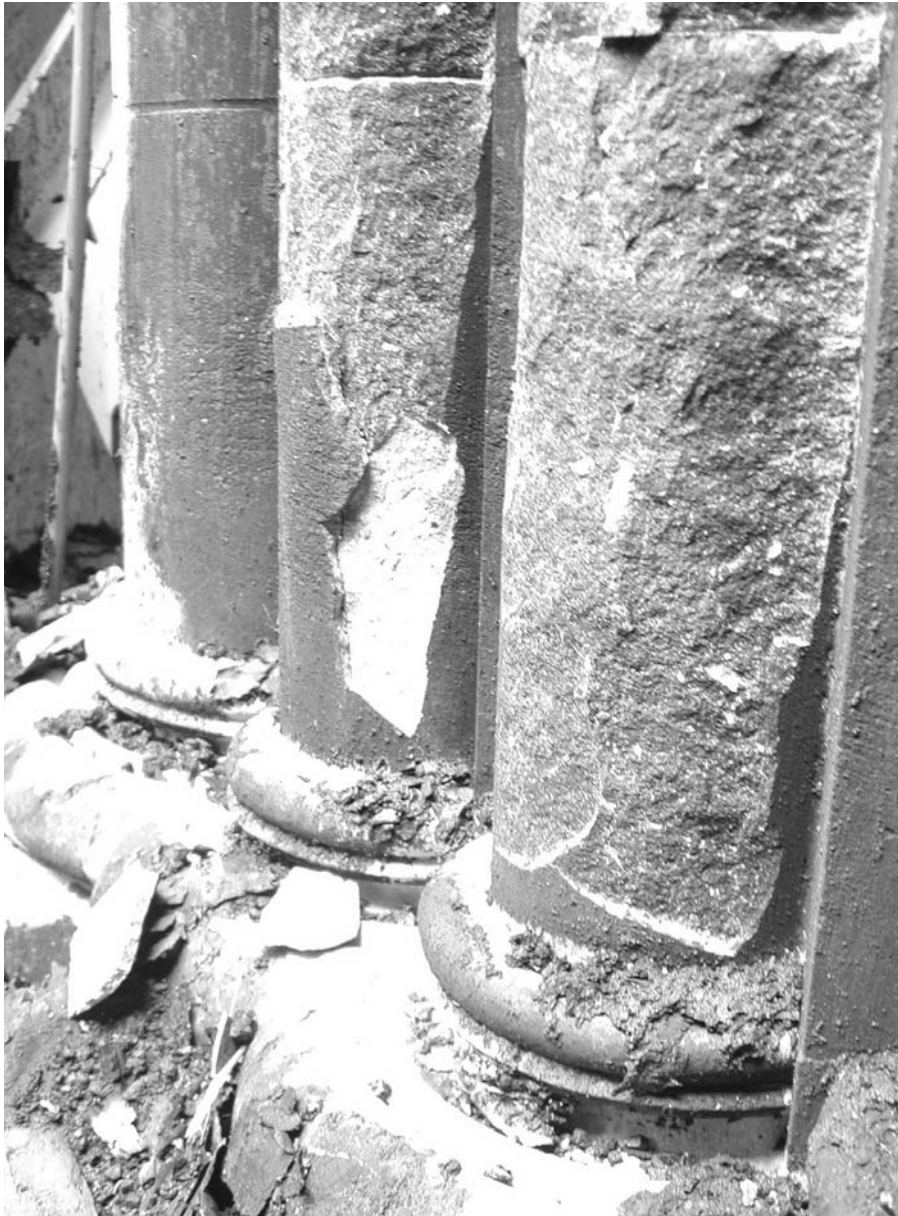
Figure 4 The limestone in the north transept exhibits spalls from the stresses caused by the heat from the fire followed by sudden cooling when the water used to extinguish the fire hit the stone. The stone was blackened by the deposition of smoke, which was heavily laden with bitumen.

exterior stone walls, spalls continued to develop for days after the fire. Smaller losses occurred for some months (Figure 4).
