Two Aesthetic-Movement Rooms: Research and Conservation

Claudia Kavenagh and
Raymond M. Pepi

Conflicting objectives
created challenges
during an interior
restoration in
New York City.

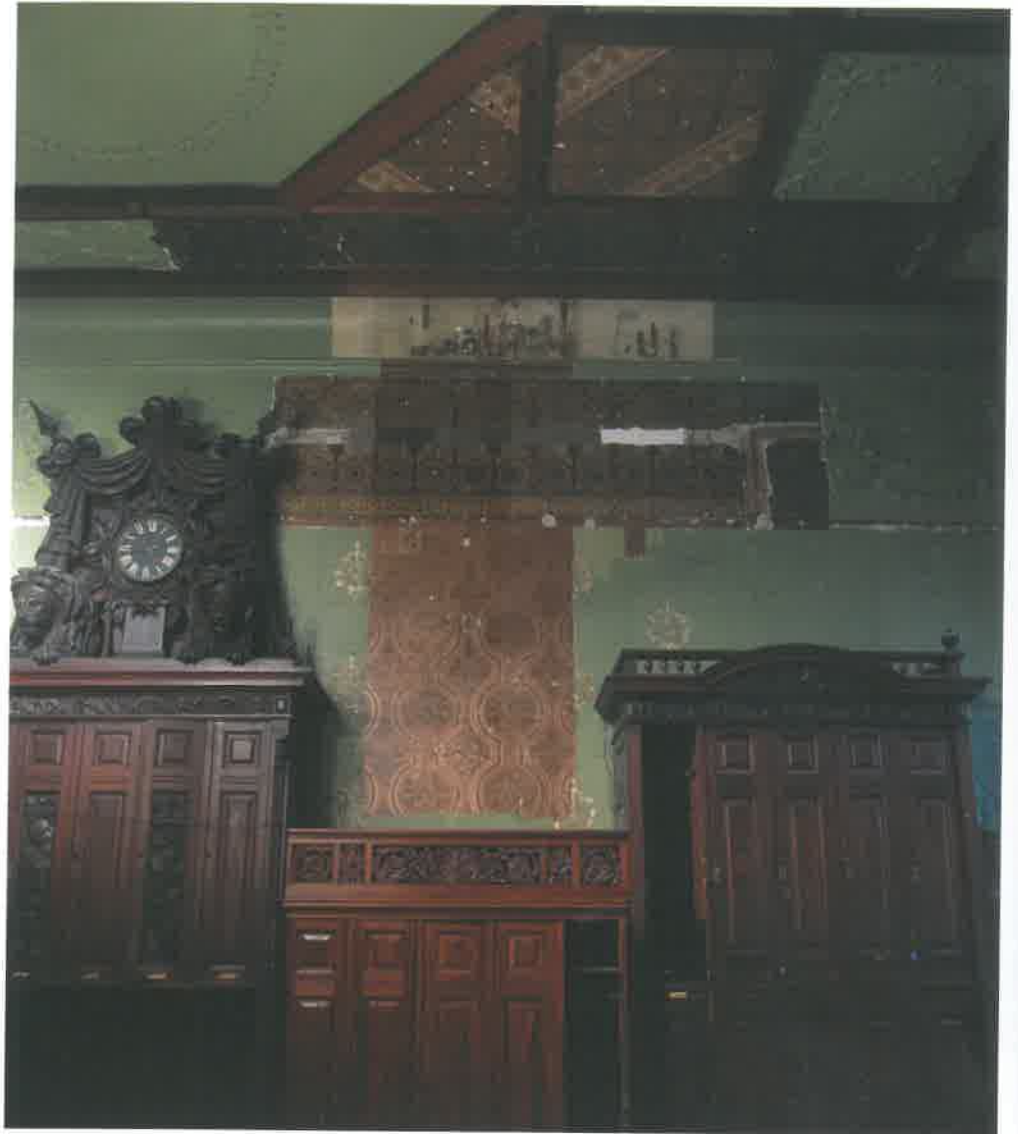
Fig. 1. Seventh Regiment Armory, New York, New York, built 1880, Company Room D, mock-up of proposed treatments on a "slice" of the room, 2011. Photograph by Whitney Cox.

In each room, an area approximately 8 feet wide was selected. In this area all recommended treatments were performed on a section of the room that included the floor, the cabinets, the walls, and the ceiling. Stationary pipe-frame scaffolding was erected in each room, and BCA conservators, assisted by interns retained by the Park Avenue Armory Conservancy, used the techniques developed during small-scale tests to create samples of the anticipated final product on the wall and ceiling surfaces (Fig. 1).²

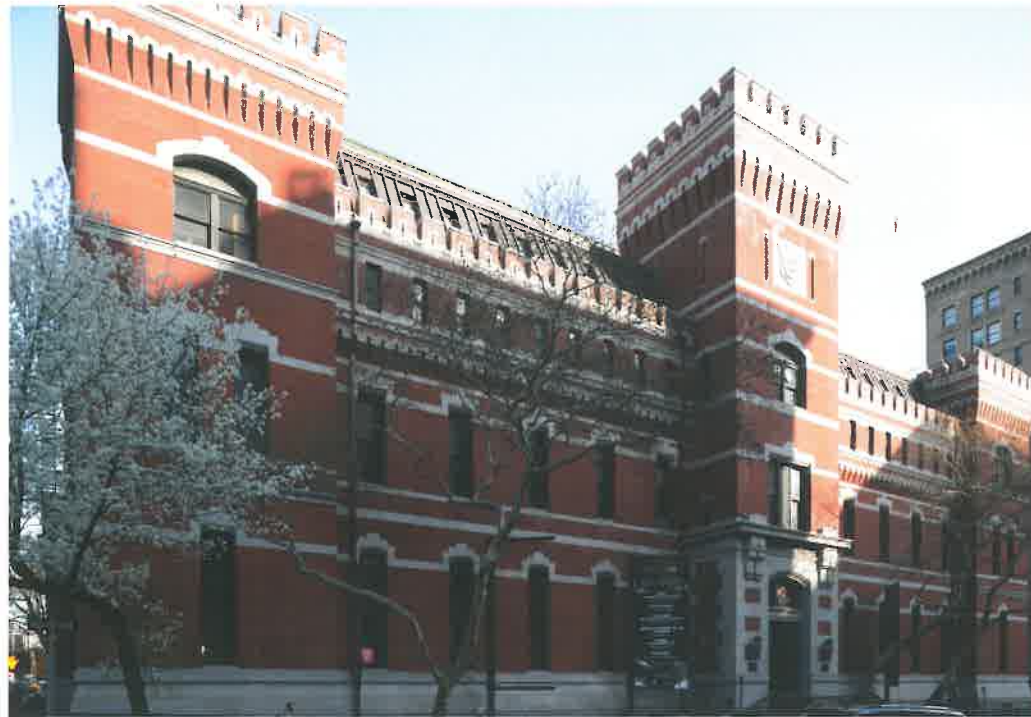
Fig. 2. Seventh Regiment Armory, looking southeast, 2015. All images by Building Conservation Associates unless otherwise noted.

The armory is owned by the State of New York, which leases the building to the Seventh Regiment Armory Conservancy. The conservancy, now known as the Park Avenue Armory Conservancy, has adapted the building from its fortress-like structure to a multipurpose arts venue visited by thousands of patrons (Fig. 2).

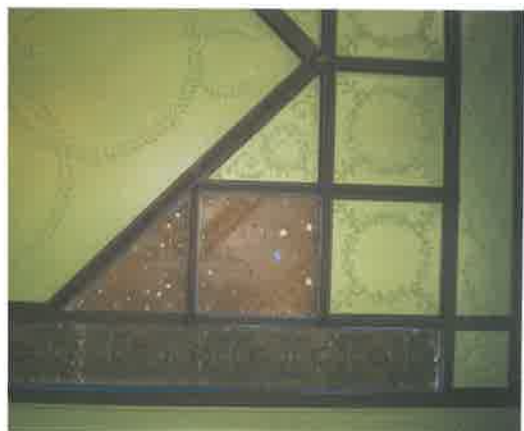
Fig. 3. Portion of Company Room D ceiling. Cast-plaster panels had been nailed over the original 1880 painted finishes. Here, several of the panels have been removed.

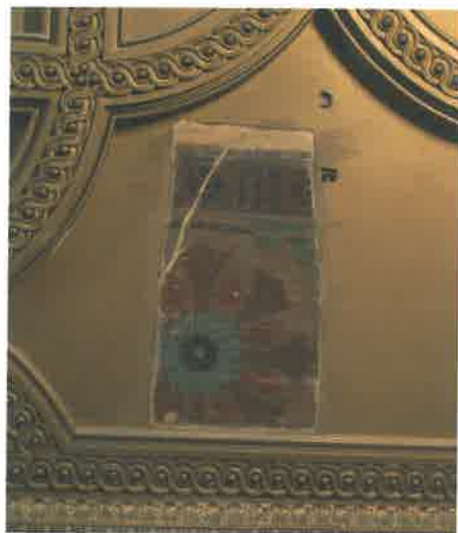
Fig. 4. Company Room E, detail of ceiling showing small-scale test of removal of overpaints. The process involved several separate steps, each with a different paint-ripper formulation.

The design work moved through a sequence of phases, starting with archival research to gain as much understanding as possible from available documentation, followed by physical investigation of the spaces, including the opening of probes. In many spaces, the original finishes remained, in varying conditions, under later layers, and small-scale testing in-situ suggested that they could be revealed on a larger scale. Some of the 1880 finishes were relatively easy to expose (Fig. 3). Exposure of others was much more complex, requiring careful removal of several layers of over-paint (Fig. 4).

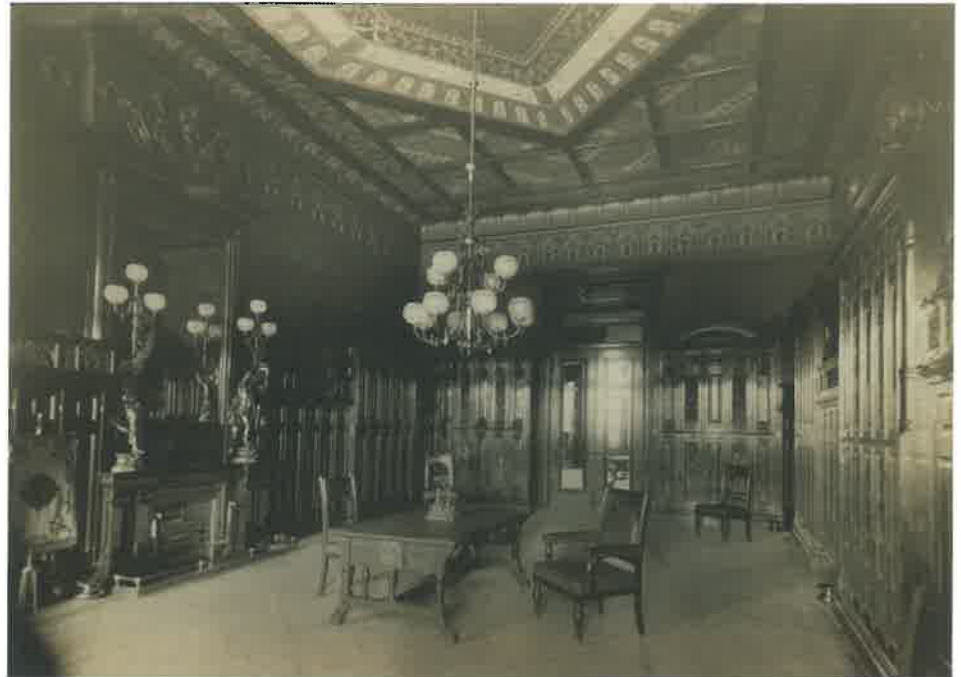
Fig. 5. Company Room D, shortly after completion in 1880. Photograph by Pach Brothers, courtesy of New-York Historical Society.

Two second-floor rooms were selected for the pilot project: Company Rooms D and E, which were originally decorated by Pottier & Stymus, a prominent New York City-based decorating firm. The rooms are large, each measuring approximately 40 feet long and 25 feet wide, with 18-foot-high ceilings. Both rooms have been altered several times over the years (Figs. 5 through 8).

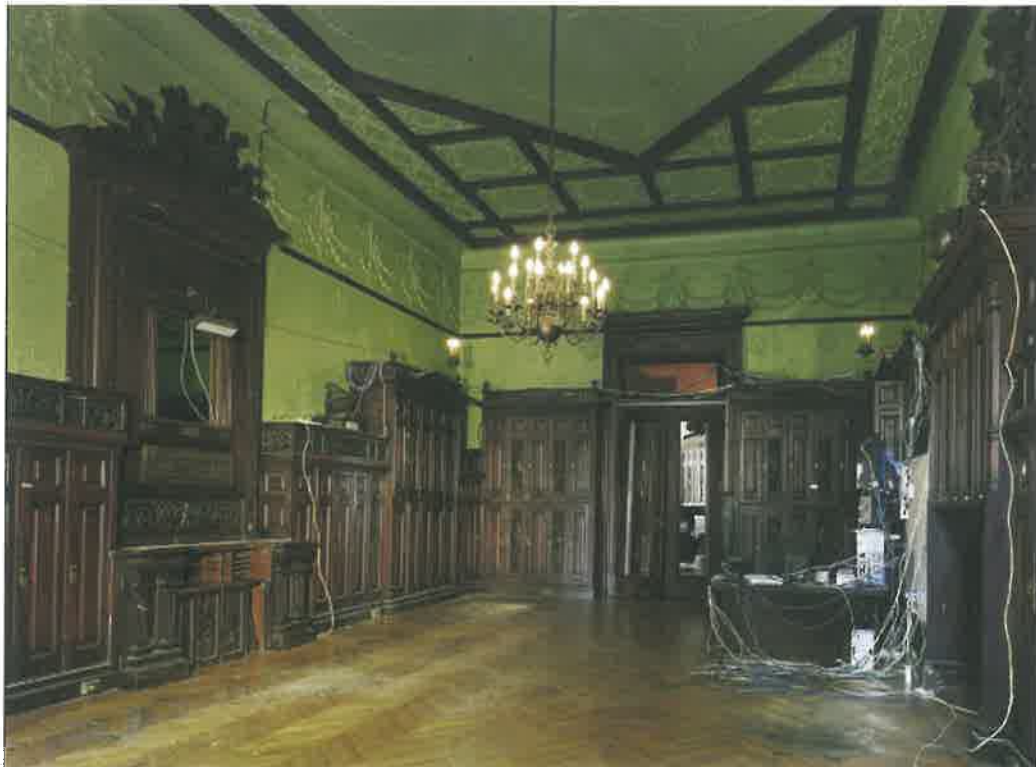
Fig. 6. Company Room D in 2007, at the start of the investigation phase of work.

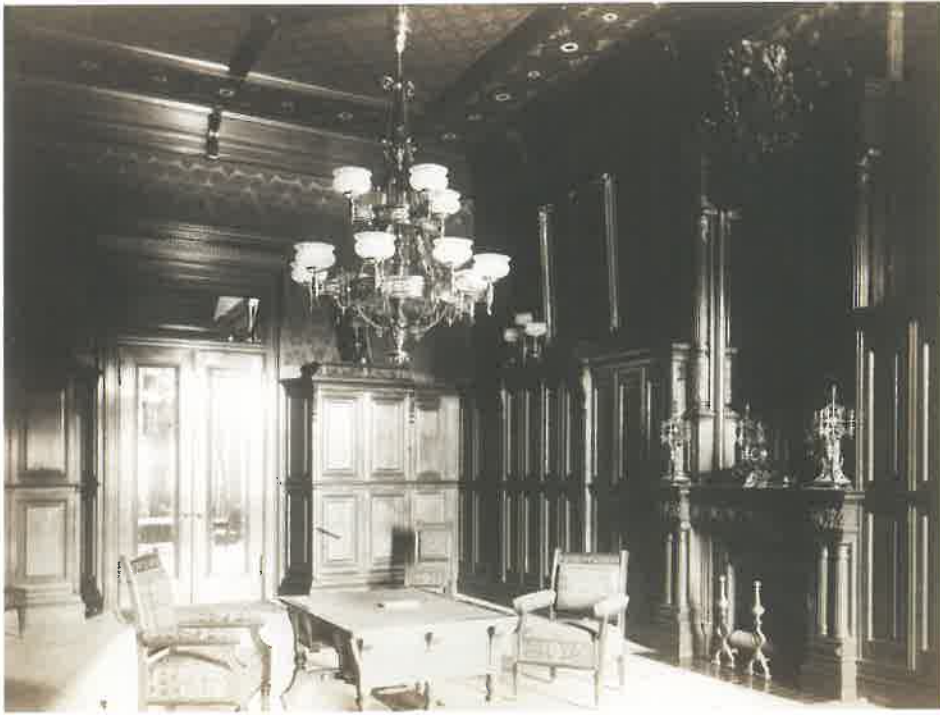
Fig. 7. Company Room E, shortly after completion in 1880. Courtesy of New-York Historical Society.

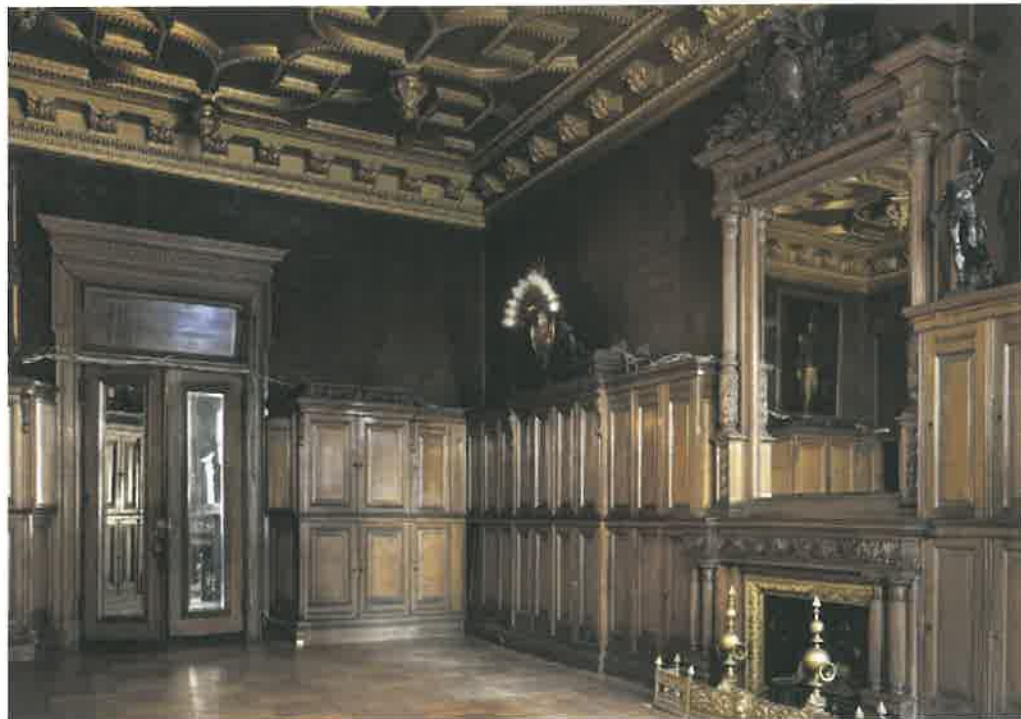
Fig. 8. Company Room E in 2007, at the start of the investigation phase of work.

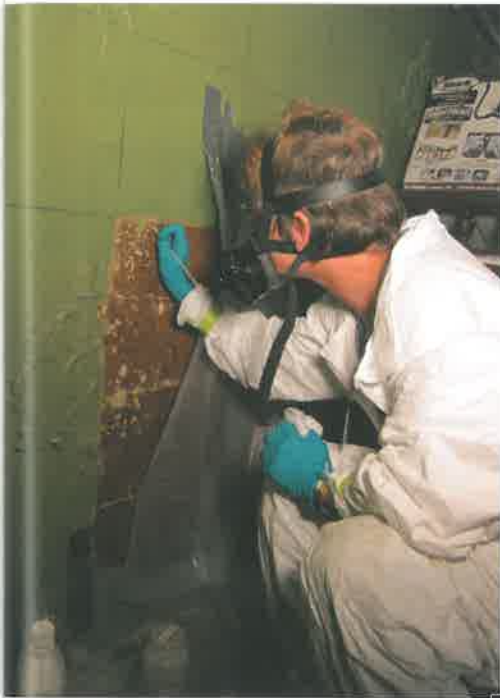
Fig. 9. Company Room D, showing Melissa McGrew of BCA testing non-proprietary paint removal formulations on the wall, 2010.

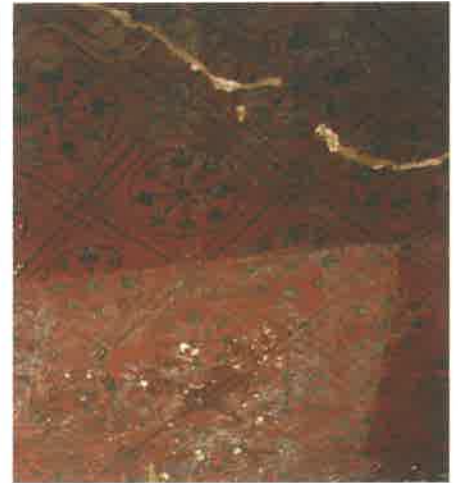
Fig. 10. Company Room D, detail of ceiling, 2011. Overpaints were only partially removed. At the bottom half of the image, the surface is unvarnished, and overpaints are visually distracting. The top half of the image is the same surface but with a varnish applied to it. The overpaints are still visible, but the impact is muted by the saturation of the colors that comes with application of a varnish.

A varnish coat will saturate colors and conceal the haze that may remain following incomplete removal of over-paints. A decision not to varnish would require the highest level of care in removing the over-paint, cost more, and take longer. Without knowing what the final treatment and appearance would be, varnishing was not originally specified. However, during construction, once it was clear that the contract conservator could complete the work far more rapidly if remnants of over-paint were left on the surface and then concealed with a varnish coat, the team elected to apply a coat of varnish to stay in budget and on schedule. The implication of this decision is that these surfaces will always need a varnish to achieve the level of appearance they currently have (Fig. 10).

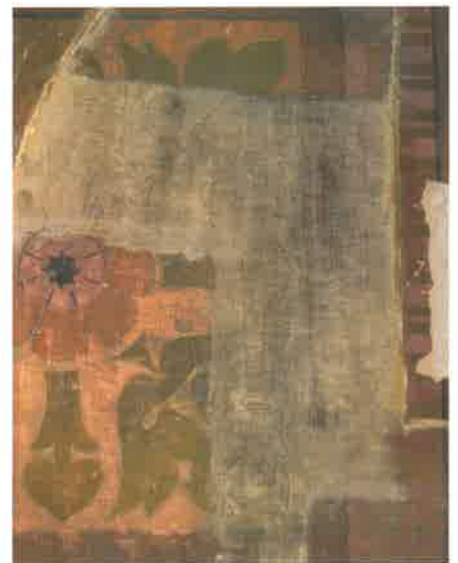
Fig. 11. Company Room E, detail of ceiling, 2011. The whitish color is the thin, resistant overlay; at the bottom left quarter of the image, it has been removed.

The contract conservator could move through the work much more rapidly if the work was not interrupted by periodic checking. It was decided that the level of risk associated with not checking was acceptable, and the work proceeded without the sampling and microscopy. As it turned out, that last thin layer remained consistent — and consistently resistant — so that the contract conservator could rapidly do the bulk removal, a fact that could not be known until general work was close to completion (Fig. 11).

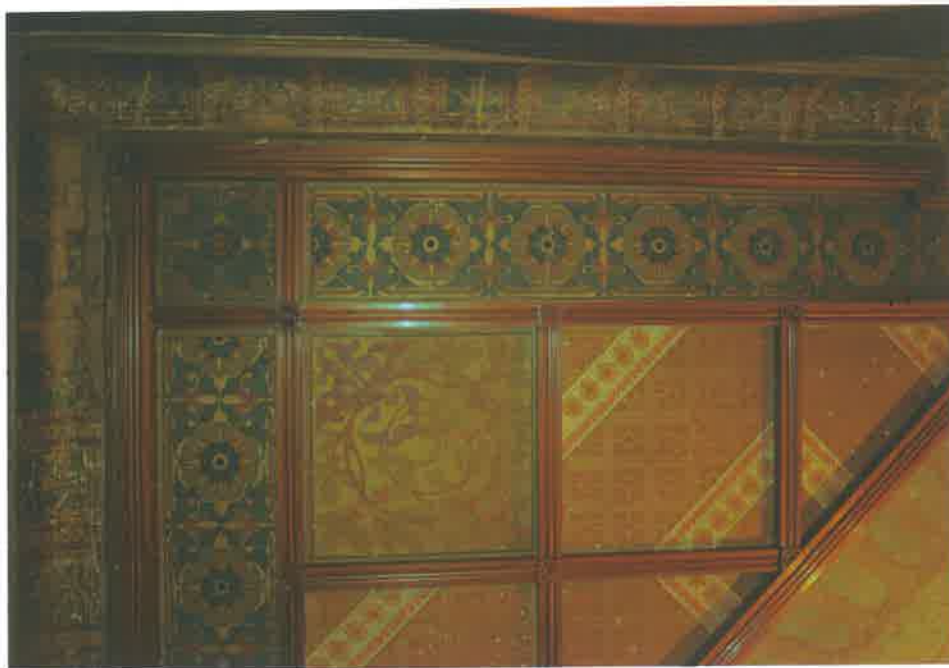
Fig. 12. Company Room D, detail of ceiling following completion of the project, 2012.

the 1880 finishes without over-painting (Fig. 12). The project required an open forum of ideas, techniques, and options at every stage. The synergy that developed among team members produced results that would have been hampered without a spirited exchange. The pilot project fulfilled its purpose, setting the stage for the treatment of the many other rooms and spaces in this National Historic Landmark.
